**Flood Control Project Maintenance
Levee Inspections**

Maintenance Issue Types Only, Levee Inspection Report By Mile - Spring 2018

Reclamation District No. 2060 Hastings

Waterway	Bank	Unit Miles	Inspection Start/End	Inspector
Unit No. 01 Lindsey Slough	Left	6.97	03/28/2018 03/28/2018	Keith Millard

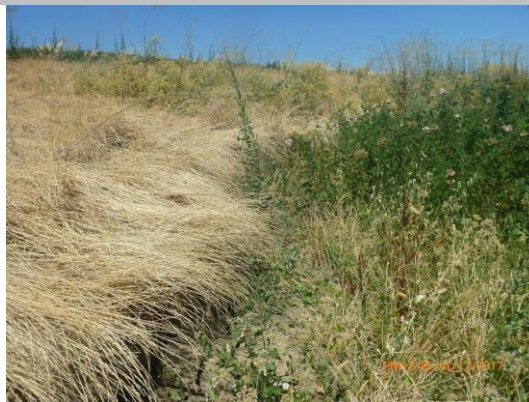
Photo 1 of 3 : SP_2018_RD2060_243_41_20180305_00079.jpg

LM Start	3.96	Rating **	A/W	Issue No.	41
LM End	4.00	Issue Type +	Ma	Location *	
Category	Supplemental		GPS Latitude/Longitude		
			Start	End	
Item	2017 Storm Damage		38.262114 °	38.261583 °	
			-121.697978 °	-121.697647 °	
DWR ID	DWR_RD2060_03_f_2017_41				
Comment Code					
Inspector Comment					
<p>Levee Evaluation Comments</p> <p>Description: Erosion commences approximately halfway down the slope and results in sloughing into the waterside toe.</p> <p>Site ID No: 411</p> <p>Site Designation: LMA-238</p> <p>Repair Type: Erosion</p> <p>Rating: Serious</p> <p>Field Date: 7/18/2017</p> <p>Notes: This site includes LMA-235. Wide erosion looks like several small sites merged. Heavy veg indicates slow erosion.</p>

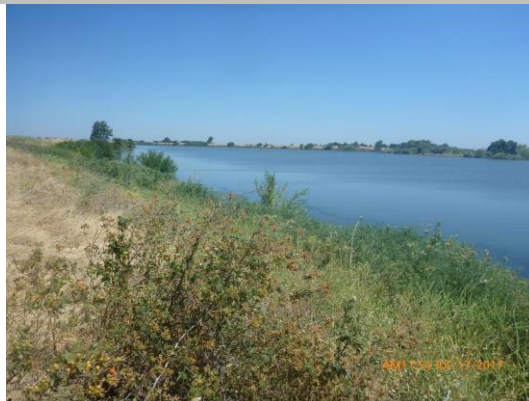
Photo 1 of 3 : SP_2018_RD2060_243_42_20180305_00082.jpg

LM Start	4.06	Rating **	A/W	Issue No.	42
LM End	4.08	Issue Type +	Ma	Location *	
Category	Supplemental			GPS Latitude/Longitude	
				Start	End
Item	2017 Storm Damage			38.260789 °	38.260644 °
				-121.696964 °	-121.696828 °
DWR ID	DWR_RD2060_03_f_2017_42				
Comment Code					
Inspector Comment					
Levee Evaluation Comments					
Description:Erosion commences approximately halfway down the slope and results in sloughing into the waterside toe. Existing rip rap has been pulled off the slope at this site.					
Site ID No:412					
Site Designation:LMA-239					
Repair Type: Erosion					
Rating:Serious					
Field Date:7/17/2017					
Notes: Small erosion. Appears that site grows slowly with each high water. The center of the eosion is a deep cut that extends below rhe waterline. Possible beaver den collapse.

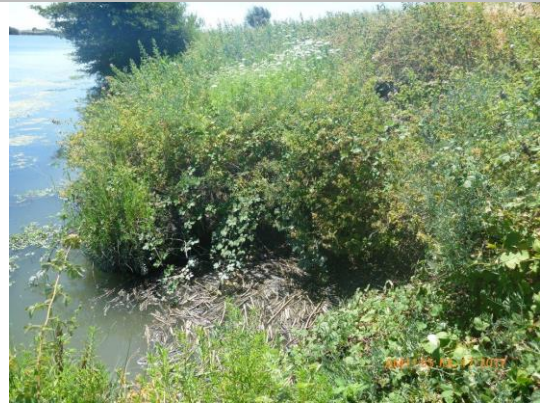
Photo 3 of 3 : SP_2018_RD2060_243_42_20180305_00084.jpg

LM Start	4.06	Rating **	A/W	Issue No.	42 (cont)	
LM End	4.08	Issue Type +	Ma	Location *		
Category	Supplemental			GPS Latitude/Longitude		
				Start	End	
Item	2017 Storm Damage			38.260789 °	38.260644 °	
				-121.696964 °	-121.696828 °	
DWR ID	DWR_RD2060_03_f_2017_42					
Comment Code						
Inspector Comment						
Levee Evaluation Comments						
Description:Erosion commences approximately halfway down the slope and results in sloughing into the waterside toe. Existing rip rap has been pulled off the slope at this site.						
Site ID No:412						
Site Designation:LMA-239						
Repair Type: Erosion						
Rating:Serious						
Field Date:7/17/2017						
Notes: Small erosion. Appears that site grows slowly with each high water. The center of the eosion is a deep cut that extends below rhe waterline. Possible beaver den collapse.

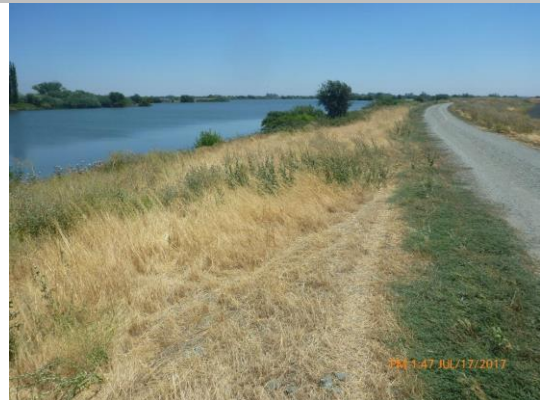
Photo 1 of 3 : SP_2018_RD2060_243_43_20180305_00085.jpg

LM Start	4.06	Rating **	A/W	Issue No.	43
LM End	4.08	Issue Type +	Ma	Location *	
Category	Supplemental			GPS Latitude/Longitude	
				Start	End
Item	2017 Storm Damage			38.260789 °	38.260644 °
				-121.696964 °	-121.696828 °
DWR ID	DWR_RD2060_03_f_2017_43				
Comment Code					
Inspector Comment					
Levee Evaluation Comments					
Description:Erosion commences approximately halfway down the slope and results in sloughing into the waterside toe.					
Site ID No:409					
Site Designation:LMA-236					
Repair Type: Erosion					
Rating:Area of Concern					
Field Date:7/18/2017					
Notes: 3' cut to slope down to water, with a 50' deep cut. Heavy veg suggests slow progression of erosion.

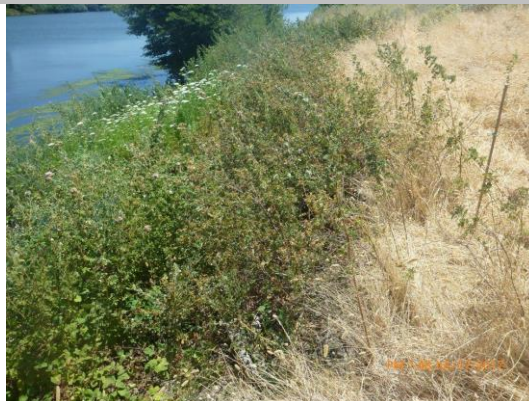
Photo 2 of 3 : SP_2018_RD2060_243_43_20180305_00086.jpg

LM Start	4.06	Rating **	A/W	Issue No.	43 (cont)
LM End	4.08	Issue Type +	Ma	Location *	
Category	Supplemental			GPS Latitude/Longitude	
				Start	End
Item	2017 Storm Damage			38.260789 °	38.260644 °
				-121.696964 °	-121.696828 °
DWR ID	DWR_RD2060_03_f_2017_43				
Comment Code					
Inspector Comment					
Levee Evaluation Comments Description:Erosion commences approximately halfway down the slope and results in sloughing into the waterside toe. Site ID No:409 Site Designation:LMA-236 Repair Type: Erosion Rating:Area of Concern Field Date:7/18/2017 Notes: 3' cut to slope down to water, with a 50' deep cut. Heavy veg suggests slow progression of erosion.
